# Product Notice – 94-0552

## RADASCAN RESPONDER PRIMARY CELL PACK BRACKET ASSEMBLY

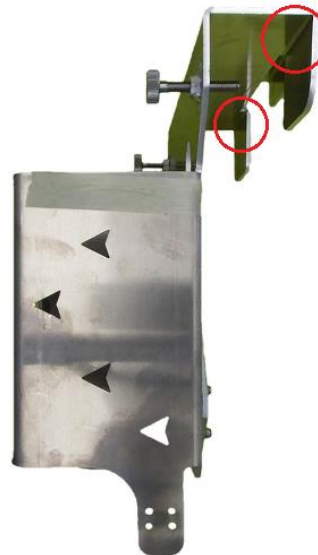
Fig 2. PCP Bracket Side View

A quality issue with the Primary Cell Pack (PCP) Bracket Assembly Mk2 has been identified where a weld has failed leading to a weakening of the handrail support. The issue affects a limited number of brackets sold between January 2016 and March 2017.

The position of the affected weld can be seen in Fig 2 below:

Guidance Marine intend to replace all brackets shipped between the above-mentioned dates. Affected customers will be contacted directly.
